# Effect of Mechanical and Thermal Loading Histories on Residual Properties of $\text{SiC}_f/\text{SiC}$ Ceramic Matrix Composites

***Presented at the 12th Pacific Rim Conference on  
Ceramic and Glass Technology (PACRIM 12)***

**Research Supported by the NASA Transformational Tools and Technology Project**

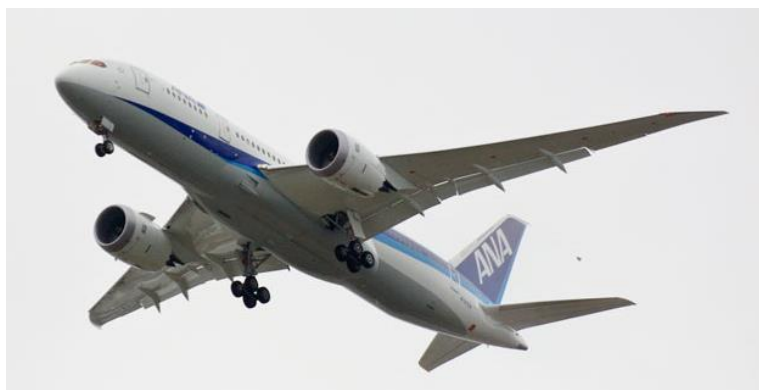
**Incentive to Increase Engine Operating Temperatures**

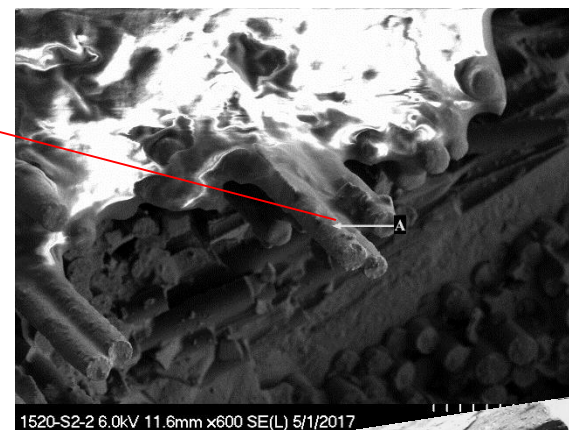
**2700 °F**  
**SPLCF, R=0.5**  
**34/69 MPa for 100 Hours**  
**Oxidation**

**2700 °F**  
**69 MPa for 100 Hours**  
**86 MPa for 100 Hours**  
**103 MPa for 100 Hours**  
**Typical Limited Fibers pull-out**

- Examination of fracture surfaces indicated CVI-SiC microcrack formation and oxidation during low cycle fatigue testing at stresses below the RT matrix cracking stress.
